2ND AND 4TH STREETS PEDESTRIAN AND STREETScape IMPROVEMENTS PROJECT TREE REMOVAL AND REPLACEMENT FACT SHEET – SEPTEMBER 2007

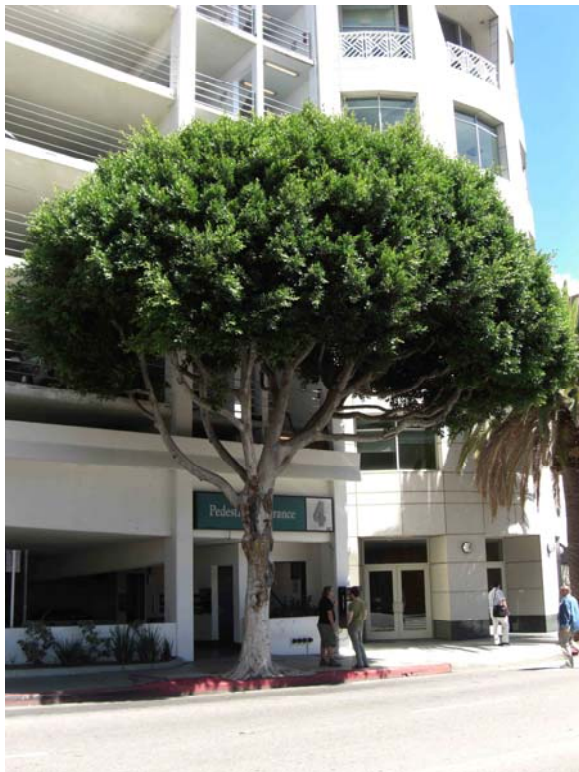
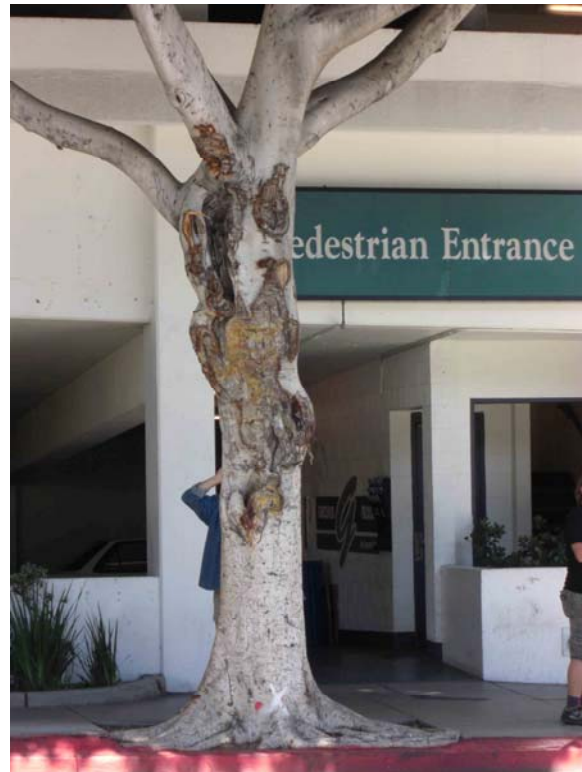
There is no corrective pruning treatment for the trees with damaged stems. The photos below show an example of one tree that has been repeatedly injured by busses. The photo on the left gives an overview of the tree. The photo on the right shows the extent of the damage to the trunk. There is no "cure" for this condition. The tree will continue to grow out over the edge of the curb, creating a continual hazard for busses that use this bus stop.

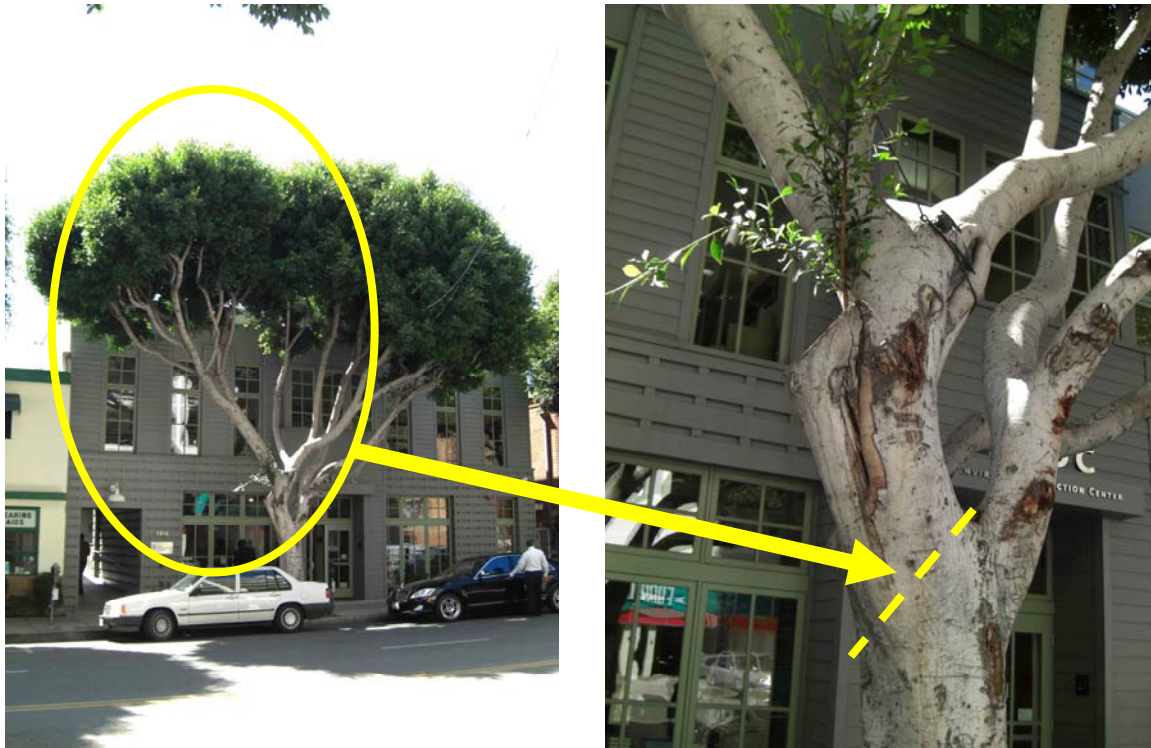
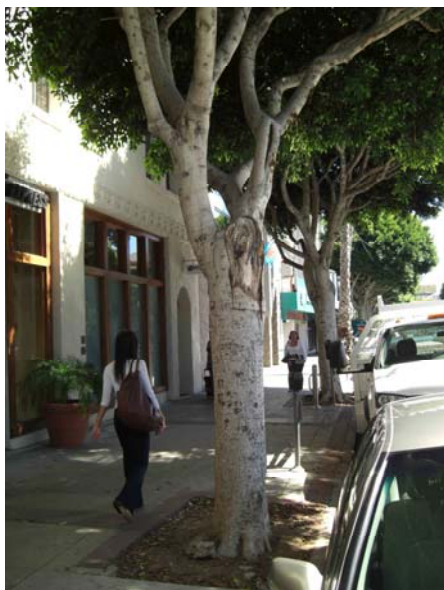
Corrective pruning treatments for trees with damage to their primary limbs can only be accomplished through extensive pruning which would create off-balanced trees which in essence would increase maintenance requirements as well as risk exposure to the public. The photos below show one example of a tree that has a large split in a primary leader. The portion of the canopy that is circled in the photo at left shows the amount of canopy that would need be removed in order to remove the large cracked limb.

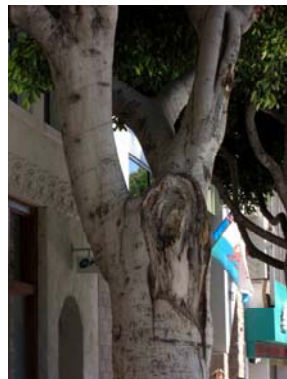
The photo at left shows another example of a tree identified for removal due to a large wound to the main stem. This wound (shown in the close up below) will eventually render the canopy of the tree unstable as a result of decay.

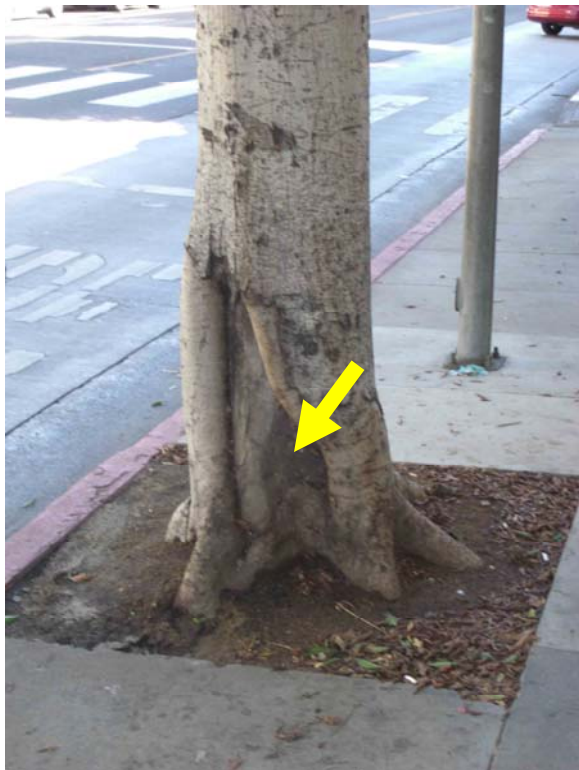
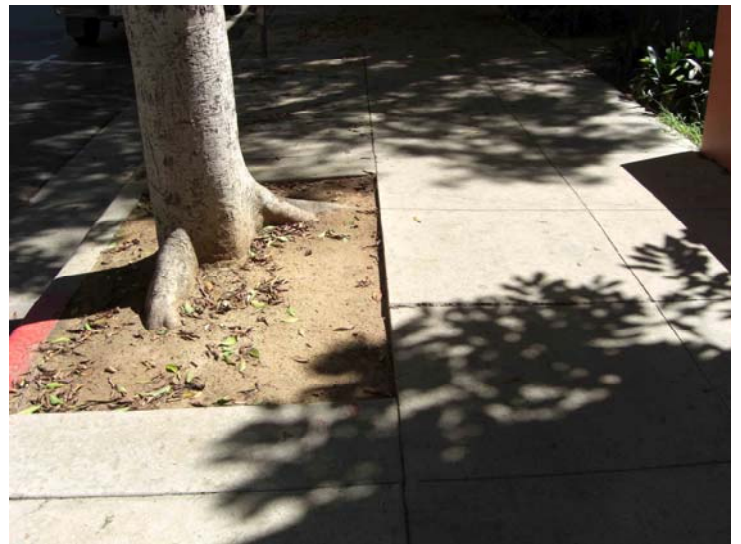
Several of the trees were identified with decay at the base of the trunk or in the root zone of the trees. Decay is an irreversible process and there is no treatment for decay. Trees with root systems that are experiencing decay due to repeated root pruning will not only decline in health they are structurally unstable. The photo at left shows an injured trunk that is in a state of decay. Note that there are a minimal amount of surface roots as well. This tree is potentially unstable and has a risk of failure. If left in place the risk will increase over time as the decay process continues to weaken the stability of the tree. The photo at right shows a different tree with a minimal amount of surface roots. This is because this tree has had a large portion of its roots removed as a result of previous sidewalk repairs.

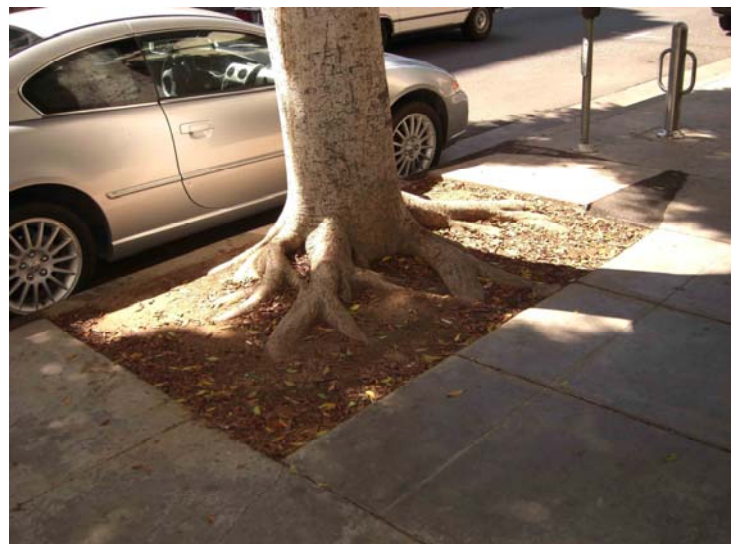
The photo at right shows a tree with a good trunk flare, adequate buttress roots and no injuries to the base of the trunk that could lead to decay.
